RV Inspection Report

Prepared for: Elite 1 RV

1 US Hwy, Site 402, New Braunfels, Tx 78131

Inspection Date / RV Model: 06-15-2022: 2022, Thor, Axis, XS24.1

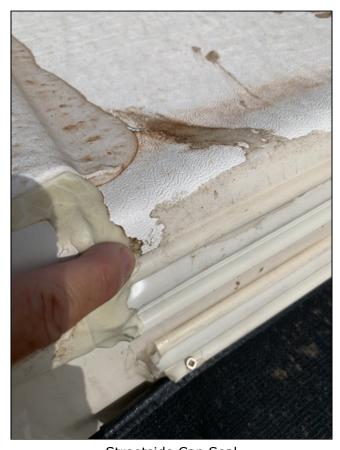
Streetside Cap Seal

(1) Inspector observed a small gap in sealant on trim rail at the streetside corner of the cap seal. It is recommended that these areas be repaired by a qualified RV technician to help prevent future water intrusion.

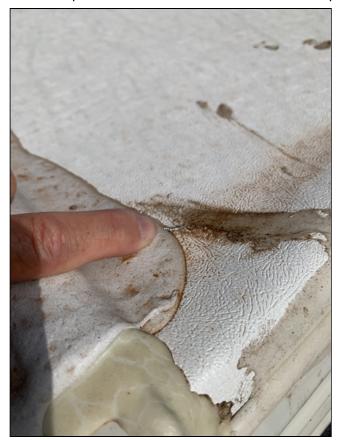
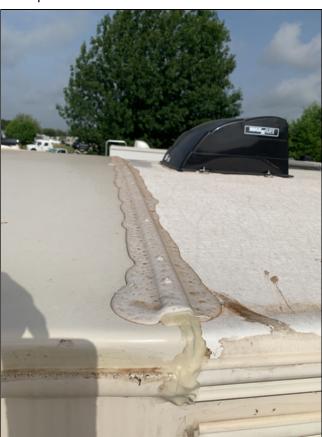
Streetside front cap seal

(2) Inspector found a small Metal shaving in sealant located on the street side corner of the cap seal recommend qualified RV technician evaluate and repair for possible future water intrusion.

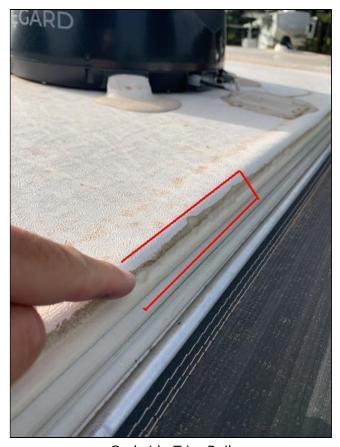
Curbside Trim Rail

The inspector observed bubbles in the sealant on the curbside of the trim rail, just behind the Winegard antenna. It is recommended this area be evaluated by a qualified RV technician to help prevent future water intrusion.

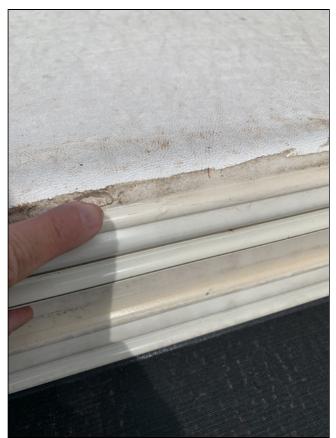
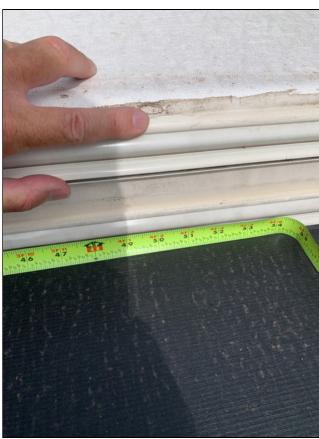
Streetside trim rail

(1) Inspector observed a small gap in sealant along streetside trim rail 50" from rear of coach. It is recommended that this area be repaired by a qualified RV technician to help prevent future water intrusion.

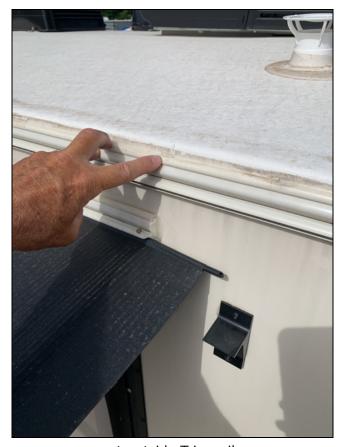
streetside Trim rail

(2) The Inspector observed cracks in the sealant at the streetside roof trim rail, just above the back corner of the slideout. It is recommended that this area be repaired by a qualified RV technician to help prevent possible future water intrusion.

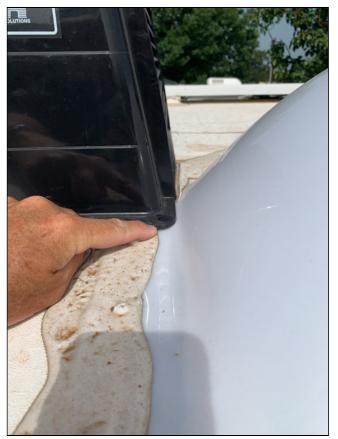
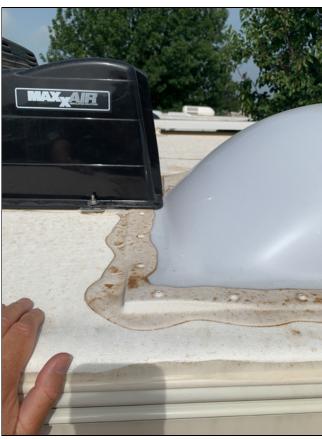
Skylight Skylight

The inspector observed the exterior vent cover overlaps the skylight on the front curbside of the roof. It is recommended that this area be evaluated by a qualified RV technician to help prevent future water intrusion.

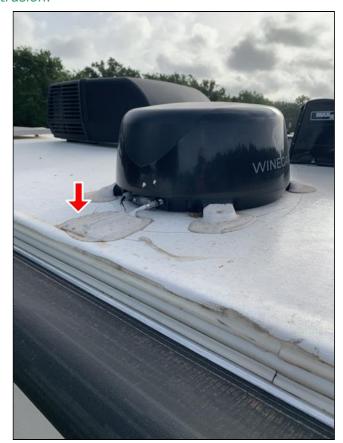
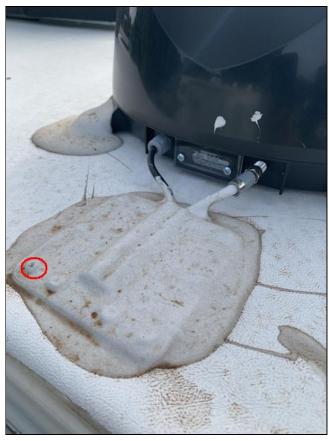
TV antenna wire access

The inspector observed a small hole on the curbside wire access sealant for the TV antenna. It is recommended that this area be repaired by a qualified RV technician to help prevent future water intrusion.

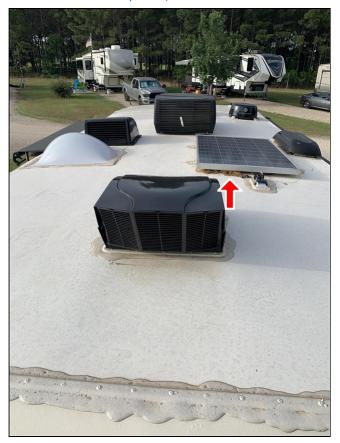
Solar Panel

The inspector observed debris under the solar panel, it is recommended this be cleared away.

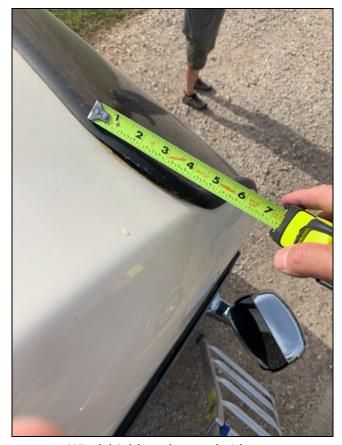
Windshield gasket curbside top

(1) The Inspector observed cracks in the sealant at the curbside top corner of the windshield. It is recommended this area be repaired by a qualified RV technician to help prevent possible future water intrusion.

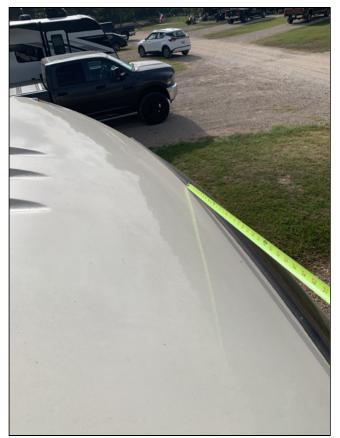
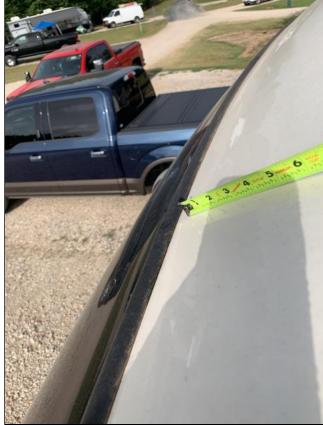
(2) The Inspector observed cracks in the sealant in two areas at the top center of the windshield. It is recommended this area be repaired by a qualified RV technician to help prevent possible future water intrusion.

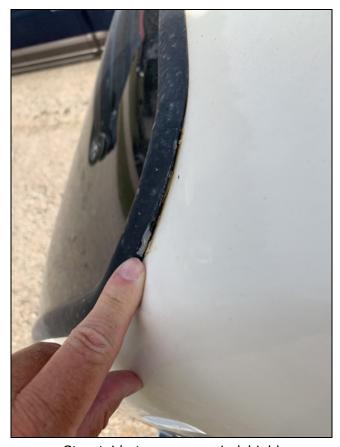
Streetside top corner windshield

(3) The Inspector observed cracks in the sealant at the streetside top corner of the windshield. It is recommended this area be repaired by a qualified RV technician to help prevent possible future water intrusion.

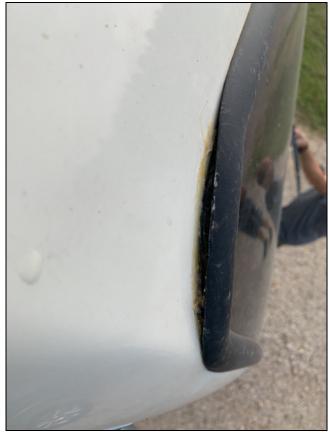
Curbside top corner windshield

杰 Inspector Observed the rubber seal around windshield is not fully making contact with the body of the coach. It is recommend qualified RV tech repair this to prevent future water damage

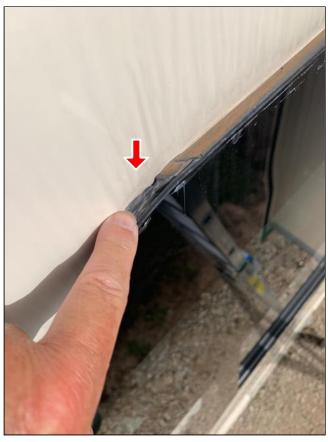
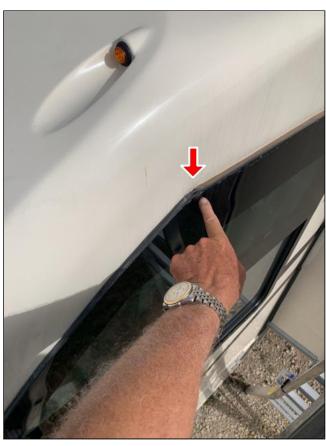
Streetside Front Window

(1) Inspector observed a gap in the sealant around the entire window on the curbside front window. It is recommended this area be repaired by a qualified RV technician to help prevent possible future water intrusion

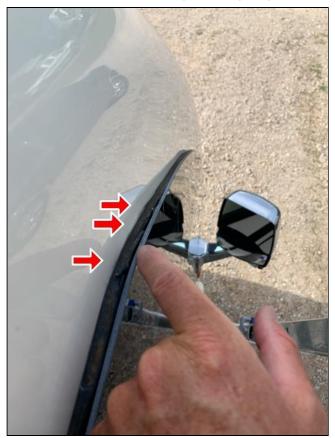
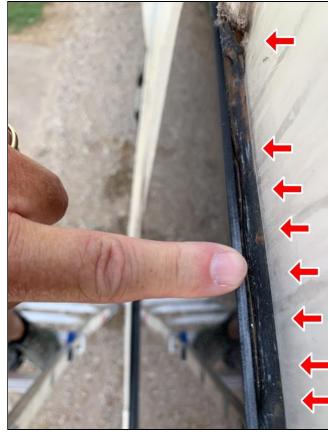
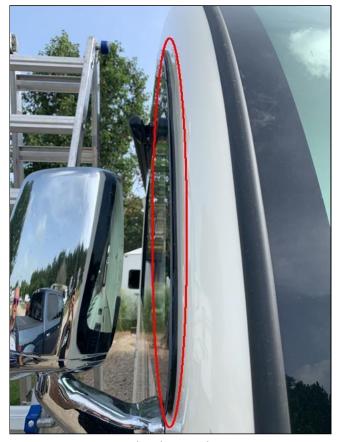
Curbside Front Window Top

(2) Inspector found a gap in sealant at the rear top of the curbside front passenger window. It is recommended this area be repaired by a qualified RV technician to prevent future water intrusion.

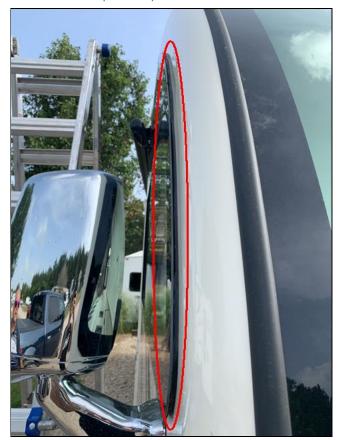
Curbside Front Window

(3) Inspector found gap in sealant around the entire window on the curbside front passenger window. It is recommend a qualified RV technician repair to prevent water intrusion and wind driven rain.

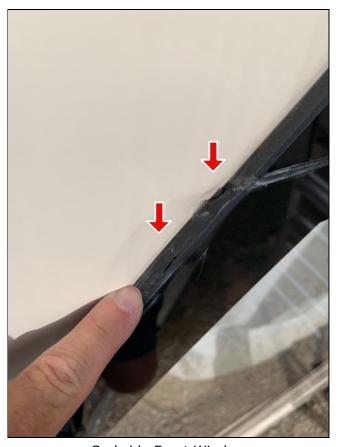
Curbside Front Window

(4) The Inspector observed sealant cracks in the sealant at the curbside corner joint of the front window. It is recommended this area be repaired by a qualified RV technician to help prevent possible future water intrusion.

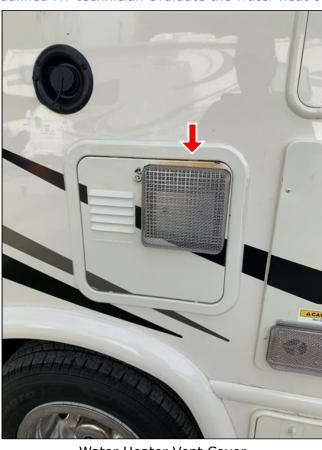
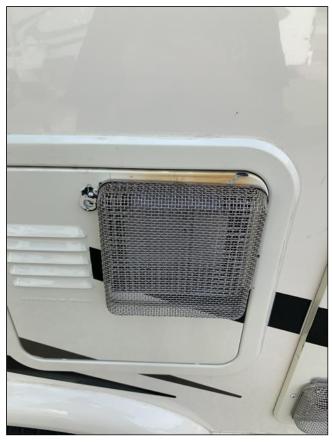
Water Heater Vent Cover

(1) Inspector observed a paint discoloration on the top of the water heater vent cover, it is recommend a qualified RV technician evaluate the water heat operation.

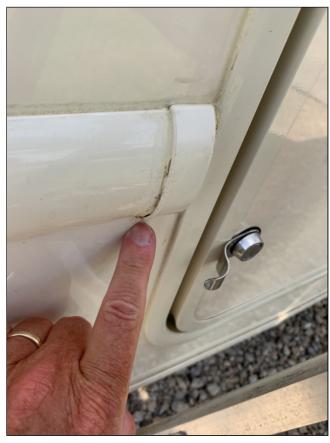
Curbs side floor joint

(2) Inspector observed Curbside floor seal cap is loose. It is recommended this area be repaired by a qualified RV technician to help prevent possible future water intrusion.

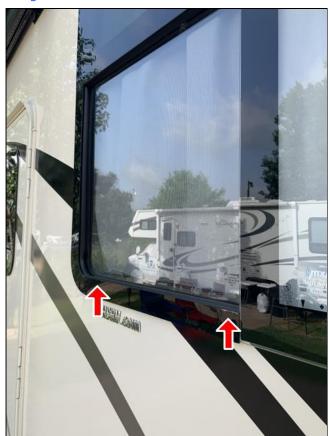
(1) The Inspector observed scratches along the bottom of the window trim, on the curbside front passenger window

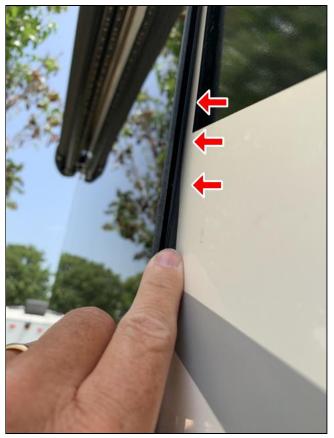
Curbside rear window

(2) The inspector observed a gap in the window gasket on the front of the curbside rear window. It is recommended this area be repaired by a qualified RV technician to prevent future water intrusion.

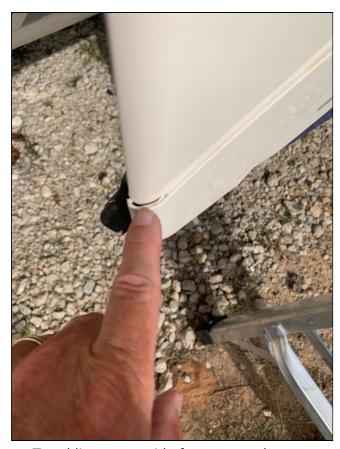
T molding street side front corner bottom

(1) The inspector observed sealant cracking on the streetside corner of the Slideout T-molding bottom front corner. It is recommended this area be repaired by a qualified RV technician to help prevent future water intrusion.

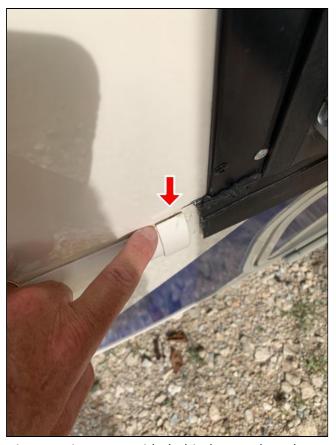
Lower trim street side behind cargo bay door

(2) The inspector observed missing sealant on the streetside of the floor molding trim cap near the slideout seal. It is recommended this area be repaired by a qualified RV technician to prevent future water intrusion.

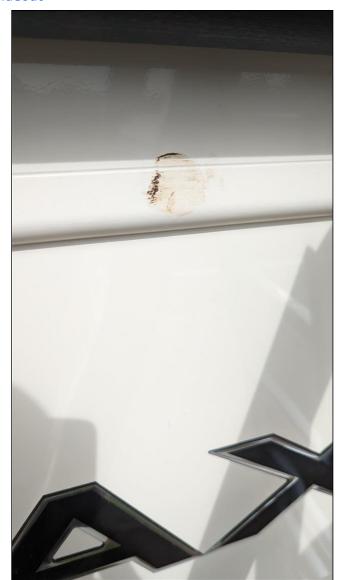
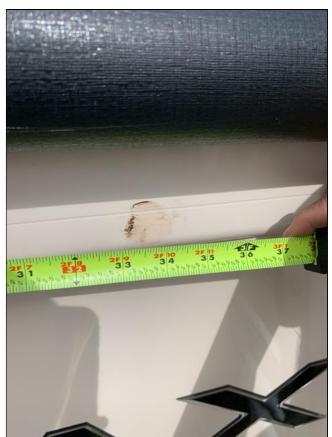
Slideout T-Molding

(2) The inspector observed discoloration on the top of the slideout T-Molding 33" from the front of the Slideout

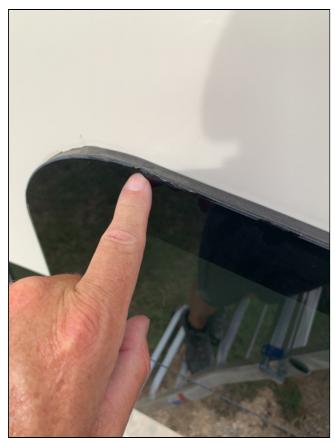
Street side window top corner left side or front side

(1) Inspector observed what appears to be chipping or ruff edge in the glass edge of the Streetside window

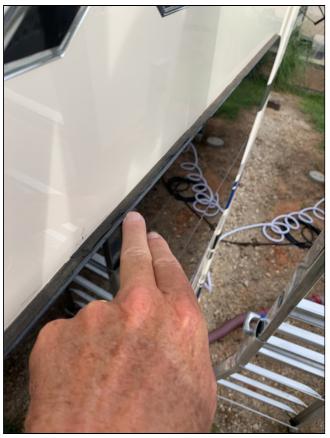
Streetside slide out window top 29-34 inches from front corner

(2) The inspector observed a crack sealant on the streetside top of the slideout window. It is recommended this area be repaired by a qualified RV technician to help prevent future water intrusion.

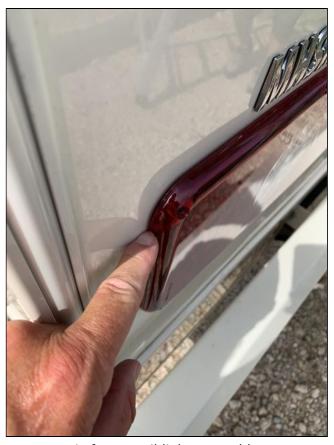
Left rear tail light assembly

(1) The Inspector Observed the streetside rear taillight assembly not fully seated against the rear cap wall. It is recommended this area be repaired by a qualified RV technician to prevent future water intrusion.

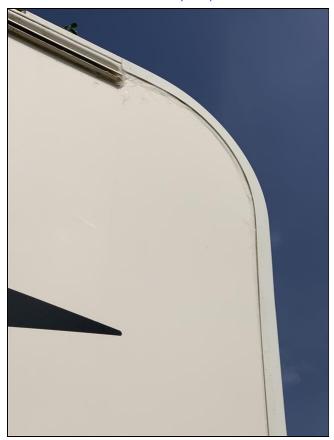
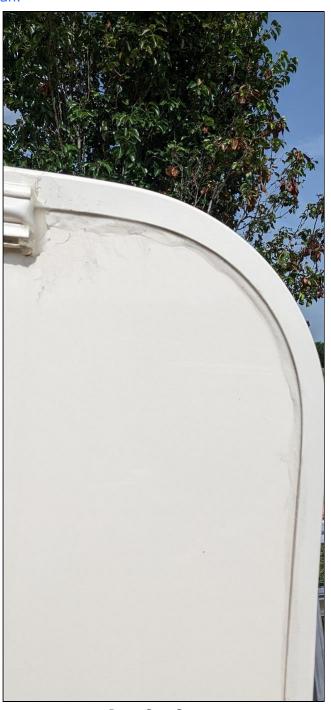
Rear Cap Streetside

(2) The inspector observed signs of repair to the streetside corner of the rear cap. It is recommended that this area be evaluated by a qualified RV technician.

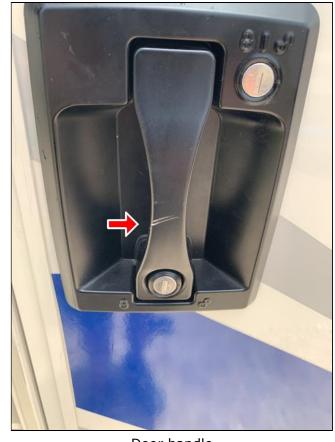
Door handle

The inspector observed a small scratch on the door handle.

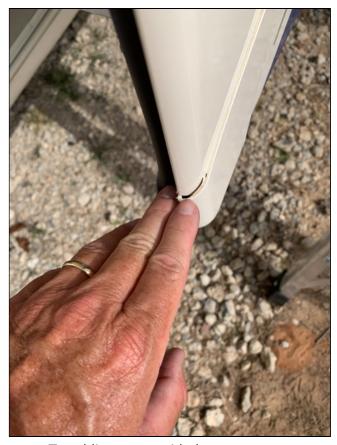
T-molding street side bottom corner

The Inspector observed sealant cracks in the sealant at the streetside corner joint of the T-Molding. It is recommended this area be repaired by a qualified RV technician to help prevent possible future water intrusion.

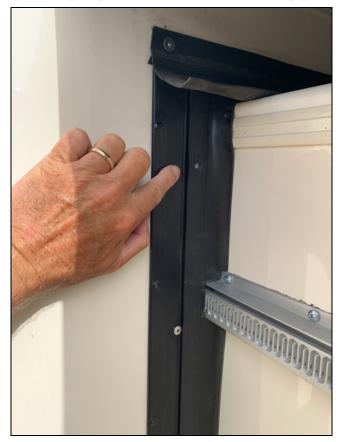
Sweep Seal top Slideout

The inspector observed a gap on the streetside corner of the sweep seal seal at the top. It is recommended this area be repaired by a qualified RV technician to help prevent future water intrusion.

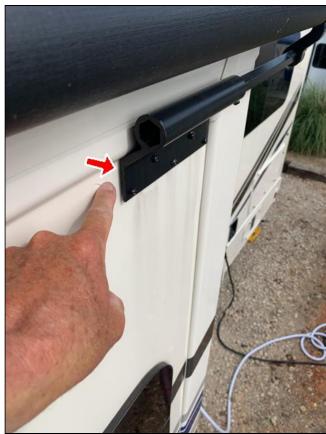
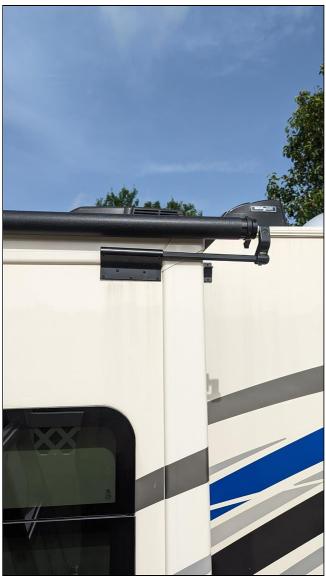
Streetside topper bracket rear bracket

(1) The Inspector Observed the rear slideout topper Bracket not fully seated against the slideout wall. It is recommended this area be repaired by a qualified RV technician to help prevent future water intrusion.

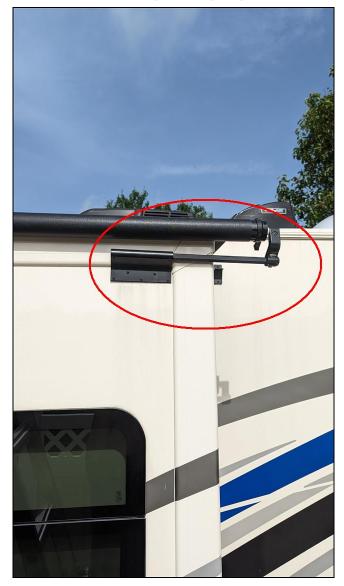
(2) The Inspector Observed the rear slideout topper Bracket not no installed in the same level alignment as the front bracket. It is recommended this be repaired by a qualified RV technician.

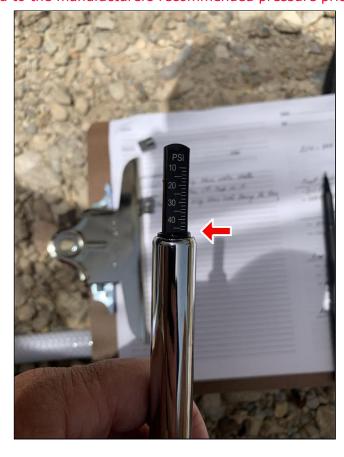
The measured tire pressure of 46 PSI is below the coach manufacturers recommended pressure of 65 PSI. This should be inflated to the manufacturers recommended pressure prior to being driven.

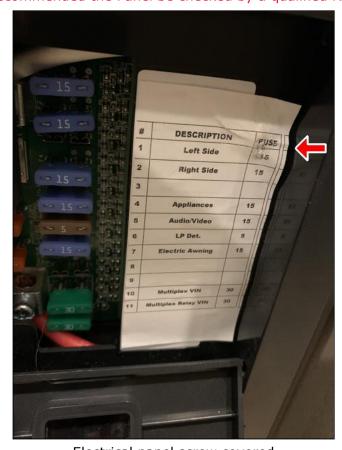
Electrical panel screw covered

Could not inspect the electrical panel without damaging the label, label was installed over the screw to remove panel cover. It is recommended the Panel be checked by a qualified RV technician.

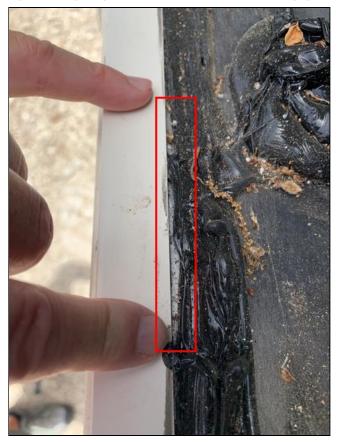
Refrigerator vent access panel

1. The inspector observed gaps in sealant on the curbside bottom of the refrigerator vent cover. It is recommended this area be repaired by a qualified RV technician to help prevent future water intrusion.

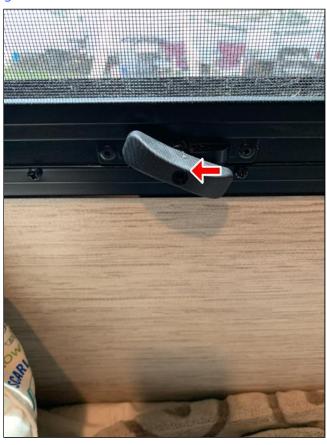
Curbside bedroom window front

Inspector observed a missing screw on the Curbside front bedroom window handle.

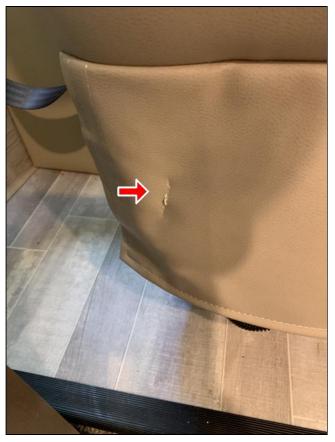
Drivers seat

Inspector observed a small tear in rear seat cover trim on the drivers seat
