RV Inspection Report

Prepared for: Elite 1 RV

1 US Hwy, Site 402, New Braunfels, Tx 78131

Inspection Date / RV Model: 06-15-2022: 2022, Thor, Axis, XS24.1

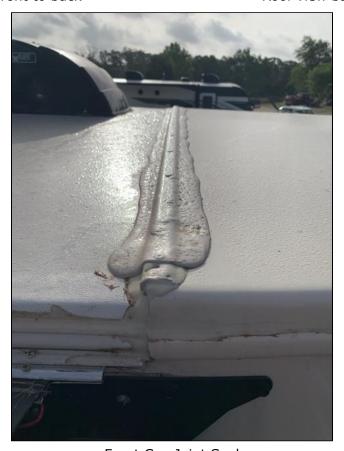
Front Cap Joint Seal

(1) Inspector observed a small gap in sealant on trim rail at the streetside corner of the cap seal. It is recommended that these areas be repaired by a qualified RV technician to help prevent future water intrusion.

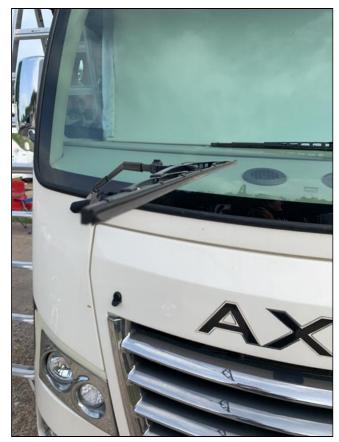
Curbside Windshield Wiper

Inspector Observed the rubber seal around windshield is not fully making contact with the body of the coach. It is recommend qualified RV tech repair this to prevent future water damage

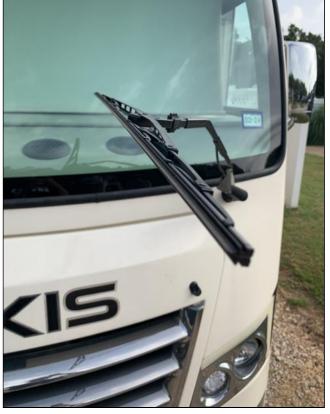
Streetside Windshield

- (1) The Inspector observed cracks in the sealant at the curbside top corner of the windshield. It is recommended this area be repaired by a qualified RV technician to help prevent possible future water intrusion
- (2) The Inspector observed cracks in the sealant in two areas at the top center of the windshield. It is recommended this area be repaired by a qualified RV technician to help prevent possible future water intrusion.
- (3) The Inspector observed cracks in the sealant at the streetside top corner of the windshield. It is recommended this area be repaired by a qualified RV technician to help prevent possible future water intrusion.

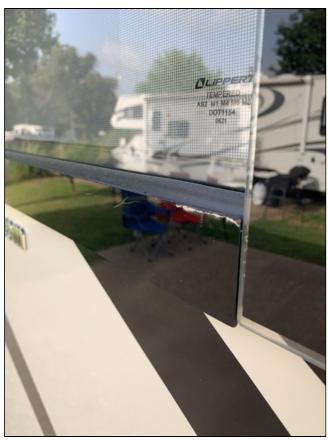
Passenger window curbside trim

(1) The Inspector observed scratches along the bottom of the window trim, on the curbside front passenger window
